CARCASS & LINER

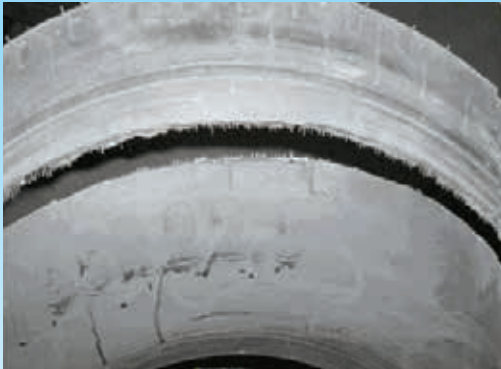
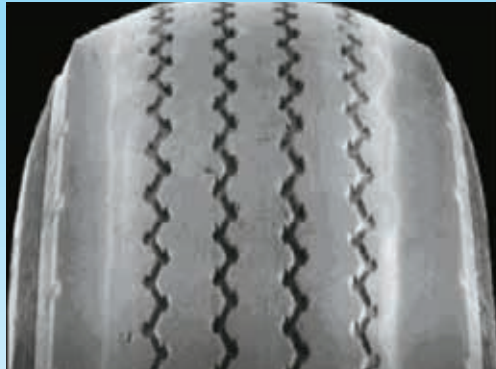
Circumferential break in the mid to upper sidewall exposing an even line of broken cords.

- Severe under-inflation or overloading which produces casing cord fatigue. This is particularly common on twinned tyres on drive or trailer positions where one of the two tyres could be carrying additional loads as a result of the other being under-inflated.

In order to find out if the damaged tyre was used under low air pressure and/or overload, inspect the tread to see whether shoulder wear/heel & toe wear/abraded marks show, and inspect the bead to see whether it is deformed/abraded.

- Use tyres under the recommended air pressure and load.
- Use dual tyres properly so that the difference of overall diameter will be minimal.
- Use new tubes for new tyres, and check valve cores to avoid air leakage.
- In case of new tyres, check the air pressure again one day after it was mounted.
- Remove moisture from insides of tyres completely when mounted.

Any tyre removed from operation that was running at 80% or below the recommended inflation pressure should be isolated from service and thoroughly inspected prior to repair or retreading. Always use a safety cage during inflation.
