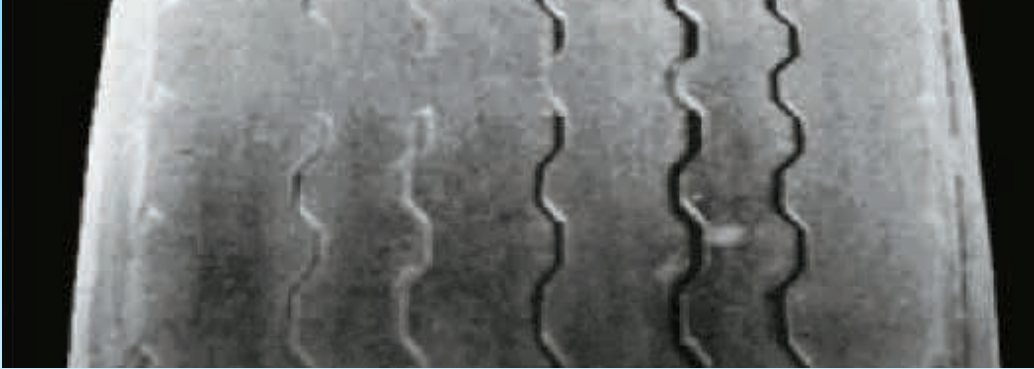
The blocks or the ribs of tread wearing in a feather edge pattern.

- Abnormal one-sided tread wear arises as a result of the tyre constraint caused by wheels being inclined to the direction of motion. Scale-like wear or feather edge wear is often seen at the shoulders. This wear pattern comes about by excessive toe-in/toe-out values or crooked axles. It also occurs if corners are regularly taken at excessive speeds. The result of the above can lead to excessive heat build up and fatigue failure of the internal casing structure.

- Axle alignment and where necessary correction of wheel or axle alignment.
- Inspect the tread visually, and measure the remaining depth of each main groove with a depth gauge.

Inspect the tread visually.
