CBU due to Cut or Shock

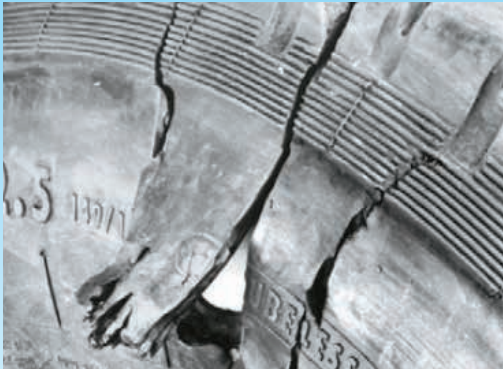
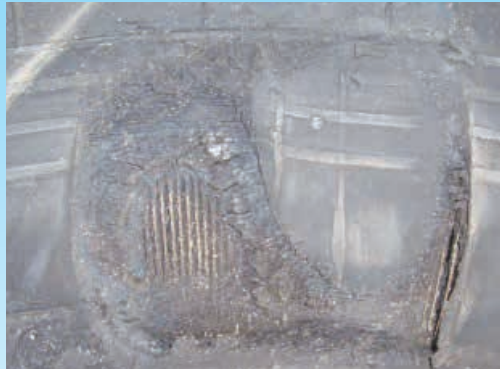
AREA: CARCASS & LINER
CONDITION: Carcass cord is broken up at shoulder and/or sidewall.

- Obstacles such as stones, pieces of glasses, nails, steel plates, etc.
- Foreign materials such as stones picked up and caught between the duals.
- A sharp edged foreign object penetrates in a localized area and causes the casing to rupture.

Check whether cut marks exist near the damaged portion on shoulder and/or sidewall. When some sidewall portion of radial truck/bus tyres swells, especially in inflated tyres, inspect the tread located at the swelled portion of the sidewall and look for the injury which damages the carcass cord under the tread.

- Drive carefully to avoid obstacles. If the obstacles cannot be avoided, reduce the speed, especially on wet surfaces.
- Check tyres frequently, and remove foreign materials between the duals.
- Use tyres under the recommended air pressure and load.
- Use proper size of rims to avoid the sidewalls contacts between the duals.
- Remove moisture from insides of tyres completely before fitting.
- Store steel radials indoors so that they are kept away from moisture, rain, wind and high humidity.
- Avoid long storage of steel radials.
