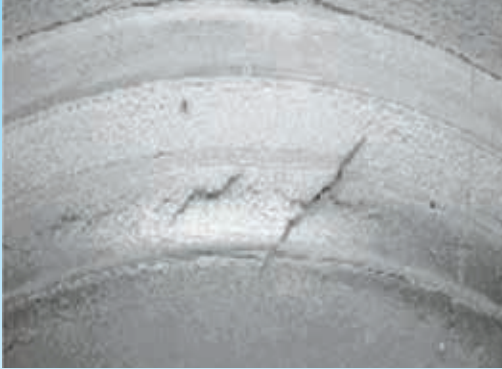
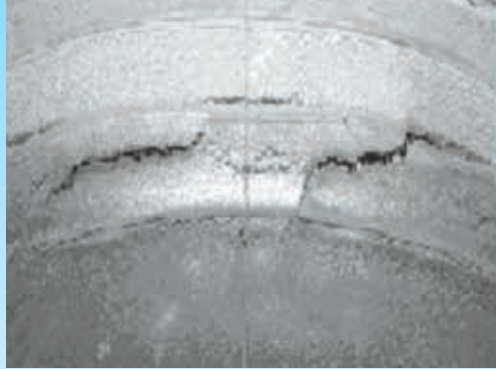
SHOULDER & SIDEWALL

Cracks in circumferential direction on the surface of shoulder or sidewall.

- Excessive deformation in shoulder and sidewall due to under inflation and/or overload.
- Growth of cuts.
- Improper branding (location, depth, etc.)
- Rubber deterioration due to ozone.

- Use tyres under the recommended air pressure and load.
- Avoid obstacles. If the obstacles cannot be avoided, reduce the speed.
- Brand properly as recommended.
- Avoid the place of storage where ozone tends to generate.

Distinguish cuts from cracks as described in "side cut".
