Truck Tyre Injury Guidance

Shoulder/Rib Tear

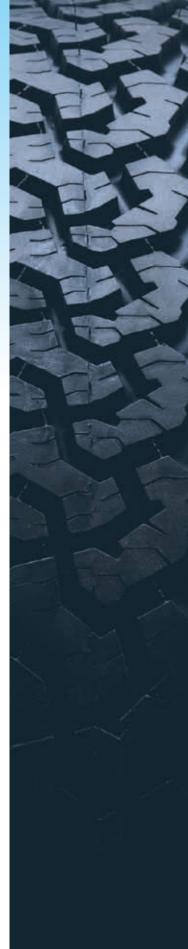
AREA: TREAD

CONDITION: Shoulder/rib is torn along its

circumference to the base of the tread

generally at the shoulder.

CAUSES:

- Running over curb stones.
- External cuts to the base of the tread.
- Under-inflation and/or overload.
- Excessive cornering forces due to either high speed driving or tight manoeuvres.

Find marks of the initial cause such as cuts by stones, steel plates etc.

RECOMMENDATIONS:

- Avoid riding over kerb stone obstacles. If they cannot be avoided, reduce the speed.
- Check tyres frequently and remove stones from groves immediately.
- Use tyres under the recommended air pressure and load.
- Avoid excessive cornering manoeuvres especially when the vehicle is stationary.
- In the case of deep cuts to the base of the tread, repair if possible.
- Review driving procedures.
- If the tyre is showing evidence as shown in the photograph above but there is no steel belt exposure remove from service and return to retreader for processing.
