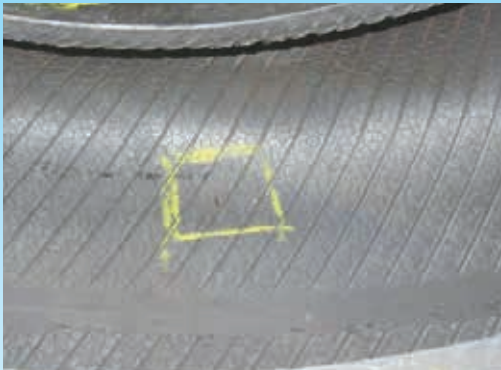
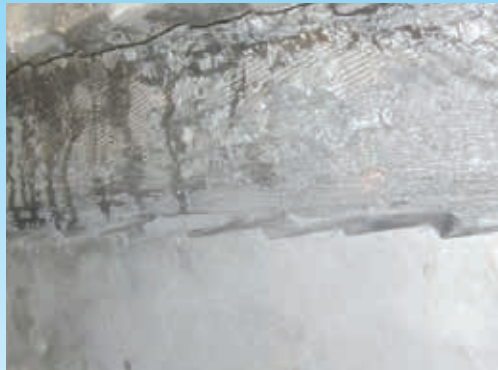
TREAD

Tread shoulder/rib is torn along the base of groove or from the shoulder due to pieces of metal such as nails, bolts and stones.

- Deteriorated adhesion by compressed air entering the casing structure, moisture, mud and sand penetrating through cuts due to obstacles.
- Developed rust in steel cords by moisture penetrating through cuts due to obstacles.
- Tyres easily tend to be cut under over inflation and/or overload.
- Running a tyre under-inflated due to a puncture, cut, leaking valve/stem/rim etc
- Sudden steering at a high speed and forced steering when the vehicle is not running.
- Heavy lateral forces against the foot print of the tyre.
- Sharp objects such as nails, sharp stones, glass and metal.
- Effects of overloading / under-inflation causes heat stress and fatigue in the shoulders which also results in failure of the casing components.

In order to distinguish cut separation from tread penetration separation, inspect the tread area near the separated portion. Normally moisture penetrates along steel cords of the belt.

- Check tyres and remove foreign materials in tread frequently, if cuts in tread are found out, repair them immediately.
- Do not overload tyres. Maintain recommended inflation pressure.
- Avoid rough/heavy steering at a high/low speeds and do not force steering when the vehicle is not running.
