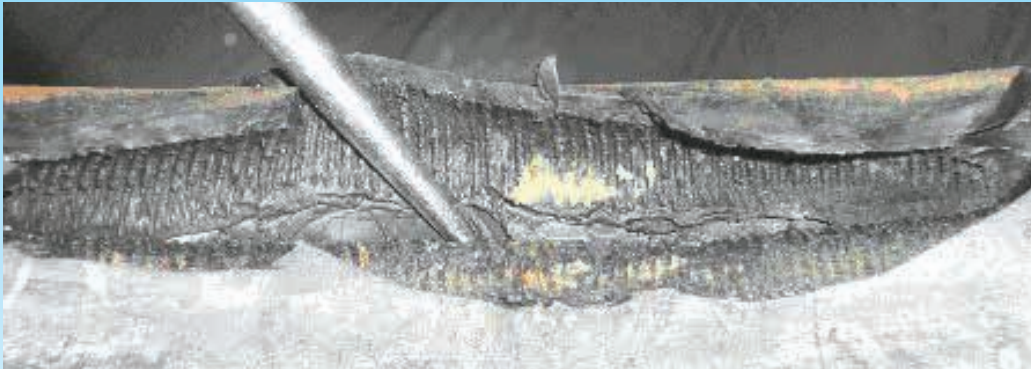
BEAD

Bead wires are completely or partially broken.

On the fractured surface, the damaged bead wires by tension look like a cone.

- Careless mounting/dismounting (omission of lubricant such as soapy water on bead, forcible mounting/dismounting, mishandling of tyre changer or tyre lever etc.)
- Incomplete mounting of tyres on rims.
- Improper size of rims and faulty rims (damaged, rusted, etc.)
- Under inflation and/or overload.

- Use the correct side of rim without deformation and rust, and inspect rims frequently.
- Mount/dismount tyres carefully and in accordance with mounting/ dismounting procedures.
- Do not overload tyres. Maintain recommended inflation pressure for the axle loads imposed.
