**SHOULDER & SIDEWALL**

Cracks in circumferential direction on the surface of shoulder or sidewall.

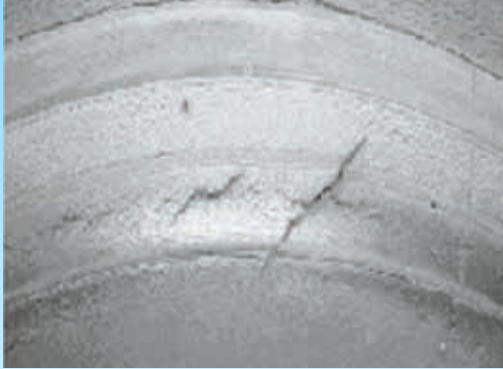
- Excessive deformation in shoulder and sidewall due to under inflation and/or overload.
- Growth of cuts.
- Improper branding (location, depth, etc.)
- Rubber deterioration due to ozone.

- Do not overload tyres. Maintain recommended inflation pressure for the axle loads imposed.
- Avoid obstacles. If the obstacles cannot be avoided, reduce the speed.
- Brand properly as recommended.
- Avoid the place of storage where ozone tends to generate.
