# Diagonal Crack

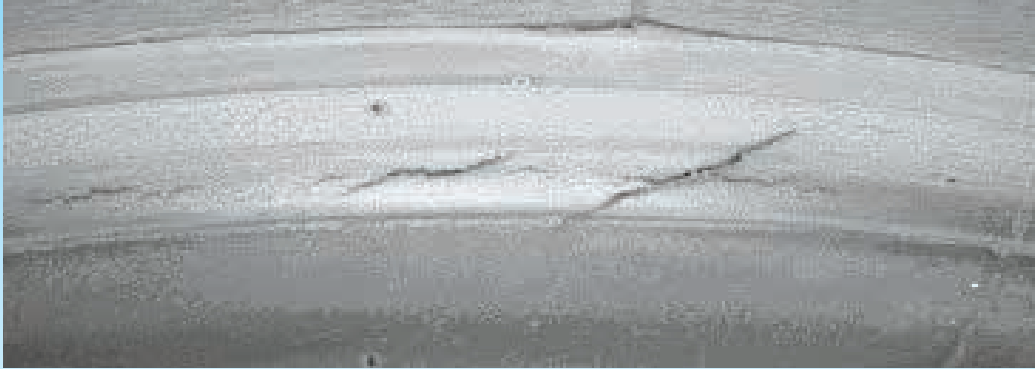
**SHOULDER & SIDEWALL**

Cracks in a diagonal direction on the surface of shoulder or sidewall on drive and trailer axles.

- Frequently can be a result of high torque transfer, aggravated by under-inflation.
- Do not overload tyres. Maintain recommended inflation pressure for the axle loads imposed.
