Truck Tyre Injury Guidance

Shoulder/Rib Tear

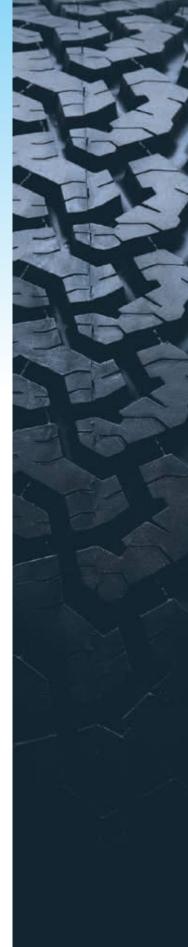
AREA: TREAD

CONDITION: Shoulder/rib is torn along its

circumference to the base of the tread

generally at the shoulder.

CAUSES:

- Running over curb stones.
- External cuts to the base of the tread.
- Under-infl ation and/or overload.
- Excessive cornering forces due to either high speed driving or tight manoeuvres.

RECOMMENDATIONS:

- Avoid riding over kerb stone obstacles. If they cannot be avoided, reduce the speed.
- Check tyres frequently and remove stones from groves immediately.
- Do not overload tyres. Maintain recommended inflation pressure for the axle loads imposed.
- Avoid excessive cornering manoeuvres especially when the vehicle is stationary.
- In the case of deep cuts to the base of the tread, repair if possible.
- Review driving procedures.
- If the tyre is showing evidence as shown in the photograph above but there is no steel belt exposure remove from service and return to retreader for processing.
