Air Leak of Tubeless Tyre

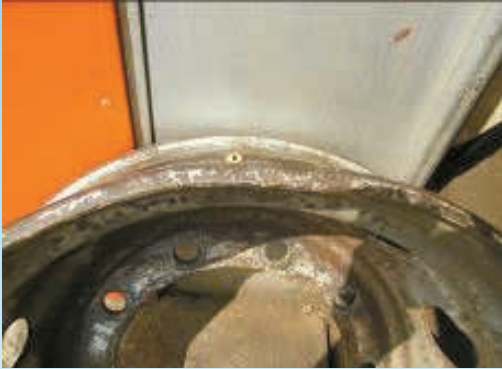
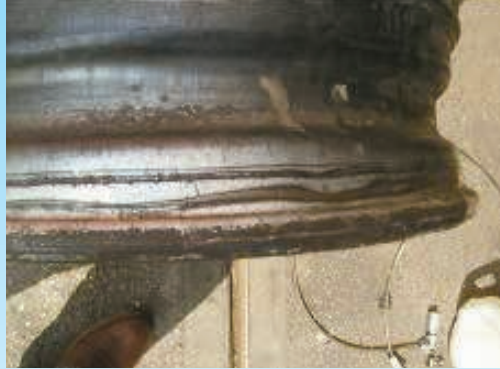
BEAD

Air leakage occurring between tyre bead and rim or in rim.

- Faulty rims (deformed, rusted, cracked, etc.) and tubeless rings.
- Improper mounting of tyres on rims.
- Tyres having bead damage.

- Use correct rims or tubeless rings without deformation of rim flange, rust, crack etc.
- Mount tyres correctly.
- Use correct tyres without bead damage.

Look carefully for air leaks in both tyre and rim assembly by using soapy water.
