# Belt Edge Separation

**AREA:** TREAD & CARCASS  
**CONDITION:** Separation at the belt edge extending to the tread centre.

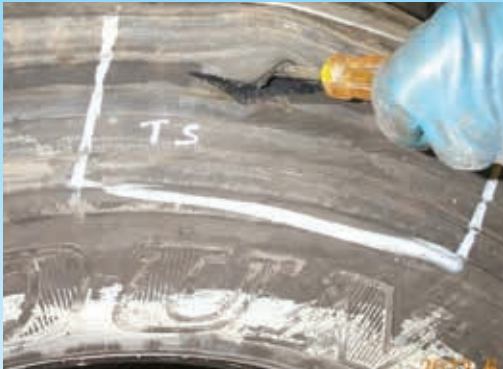
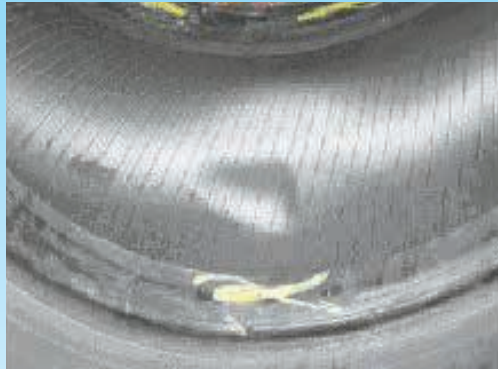
Breakdown adhesion between the belts:

- Under inflation and/or overload.
- Excessive speed.
- Fast cornering.
- Axle misalignment.
- Constant deformation of the casing structure.

To check if tyre has been over deflected inspect the inner liner looking for signs of creases (circumferential dark lines, rubber crumb) and inspect the bead area for discolouration (Blue colour) and abrasion.

Look for raised areas particularly in the area of the shoulder. This may produce excessive wear around the area of separation.

- Use tyres at recommended pressure and do not exceed maximum load (Load Index).
- Drive at an appropriate speed.
- Avoid fast cornering.
