**AREA:** TREAD & CARCASS  
**CONDITION:** Separation caused by cuts on the tread and/or shoulders.

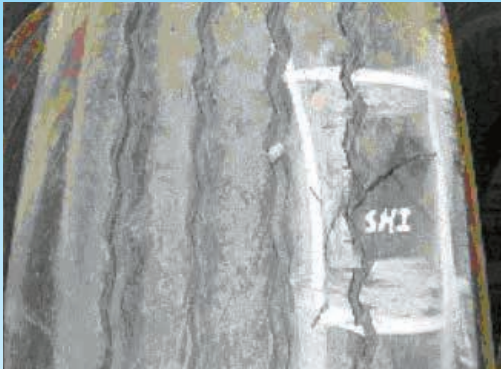
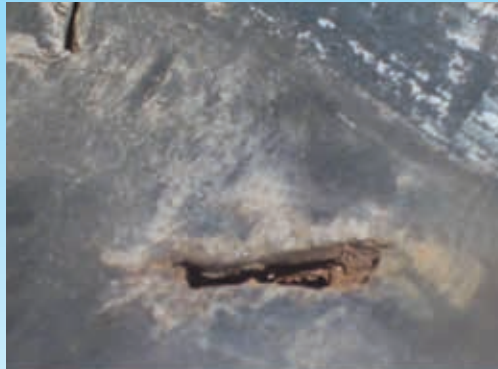
- Deteriorated adhesion by moisture, mud and sand penetrating through cuts due to obstacles.
- Developed rust in steel cords by moisture penetrating through cuts due to obstacles.
- Tyres easily tend to be cut under over inflation and/or overload.
- Under inflation and/or overload accelerates the separation.

In order to distinguish cut separation from tread separation, inspect the cut mark near the separated portion. Normally moisture penetrates along steel cords of the belt.

- Avoid obstacles. If the obstacles cannot be avoided, reduce the speed, especially on rough roads and terrains or wet surfaces.
- Select the pattern and specification appropriate for the application.
- Check tyres and remove foreign materials in tread frequently. If cuts in tread are found out, repair them immediately.
