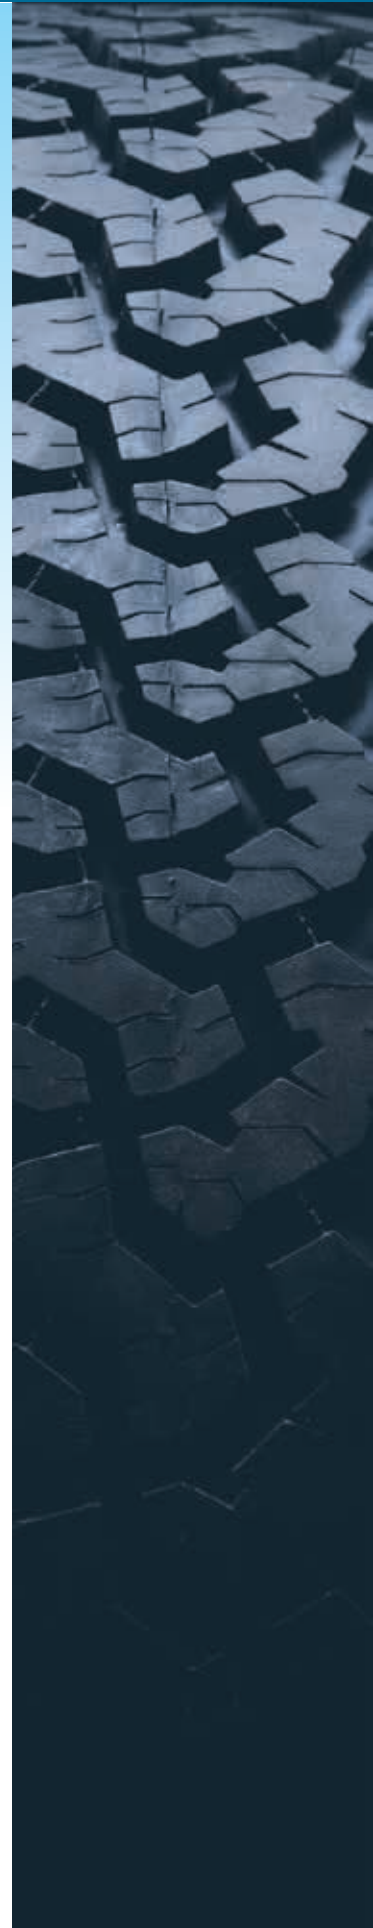
SHOULDER & SIDEWALL

Cracks in circumferential direction on the surface of shoulder or sidewall.

- Excessive deformation in shoulder and sidewall due to under inflation and/or overload.
- Growth of cuts.
- Improper branding (location, depth, etc.)
- Rubber deterioration due to ozone.

- Use tyres under the recommended air pressure and load.
- Avoid obstacles. If the obstacles cannot be avoided, reduce the speed.
- Brand properly as recommended.
- Avoid the place of storage where ozone tends to generate.

Distinguish cuts from cracks as described in "side cut".
