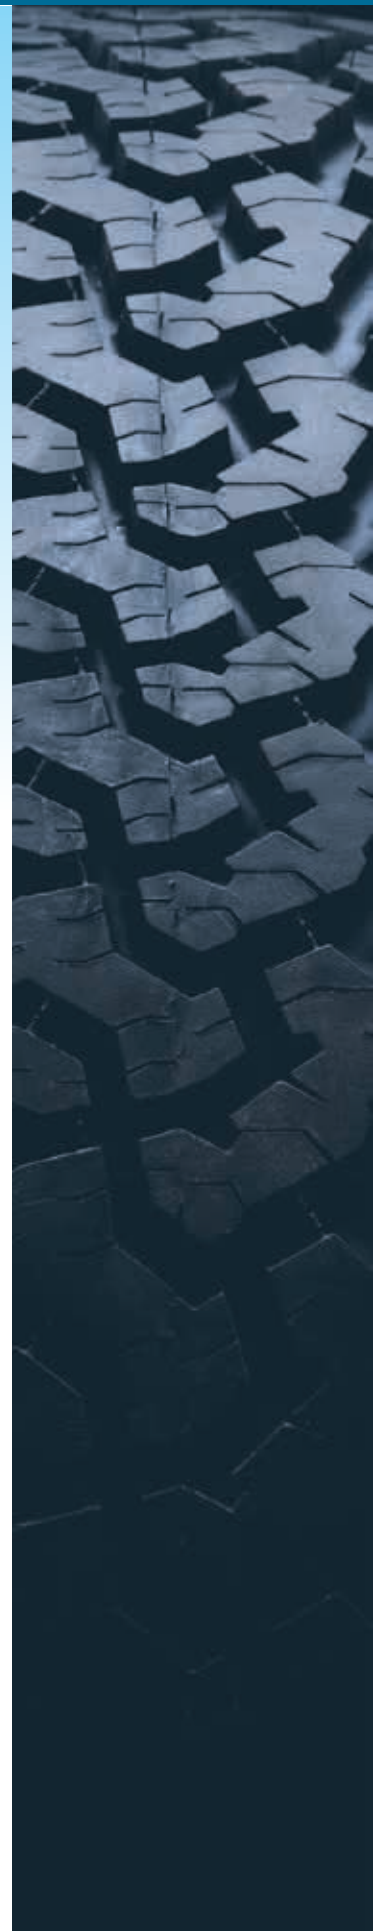
The inside injury due to foreign materials or fitting tools coming into contact with the inside of the tyre during mounting or dismounting. A series of random cuts and abrasions marks around the circumference of the inner liner.

- Careless mounting or dismounting.
- Foreign object in tyre, original manufactured liner repairs.
- Loose tyre valve components.
- Tubeless tyre fitted with inner tube and contamination between tube and liner

- Check inside of tyres and remove foreign materials every time before mounting.

Inspect the inner liner in good lighting for marks, cuts or damages.
