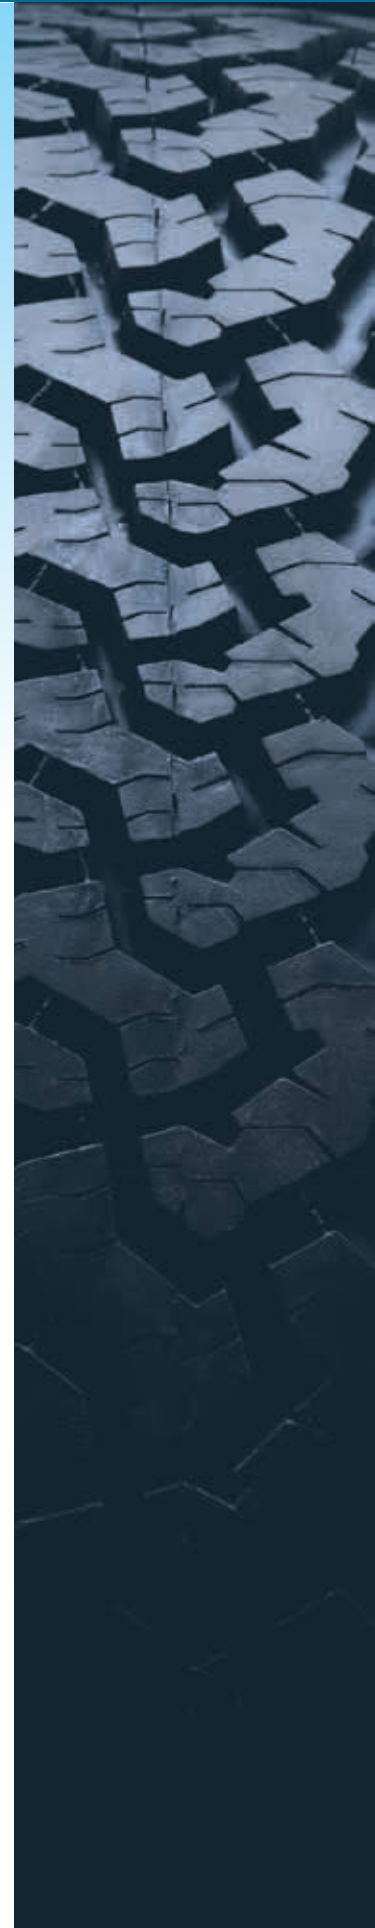
Tread shoulder/rib is torn along the base of groove or from the shoulder due to pieces of metal such as nails, bolts and stones.

- Deteriorated adhesion by compressed air entering the casing structure, moisture, mud and sand penetrating through cuts due to obstacles.
- Developed rust in steel cords by moisture penetrating through cuts due to obstacles.
- Tyres easily tend to be cut under over inflation and/or overload.
- Running a tyre under-inflated due to a puncture, cut, leaking valve/stem/rim etc
- Sudden steering at a high speed and forced steering when the vehicle is not running.
- Heavy lateral forces against the foot print of the tyre.
- Sharp objects such as nails, sharp stones, glass and metal.
- Effects of overloading / under-inflation causes heat stress and fatigue in the shoulders which also results in failure of the casing components.

In order to distinguish cut separation from tread penetration separation, inspect the tread area near the separated portion. Normally moisture penetrates along steel cords of the belt.

- Check tyres and remove foreign materials in tread frequently, if cuts in tread are found out, repair them immediately.
- Do not overload tyres. Maintain recommended inflation pressure.
- Avoid rough/heavy steering at a high/low speeds and do not force steering when the vehicle is not running.
