Truck Tyre Injury Guidance Abnormal Wear – River Wear

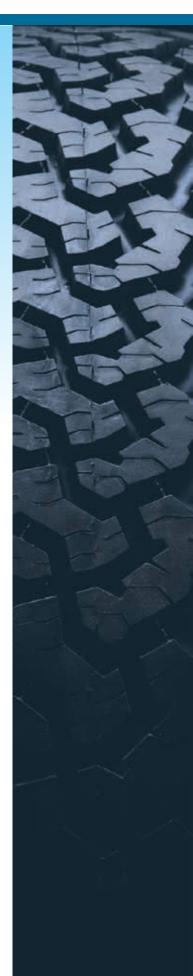
AREA: CONDITION: TREAD

Edges of the ribs except the outer edge of the shoulder ribs wearing faster than the tread surface like a riverbed.

- Under infl ation and/or overload.
- Tyres have not been rotated at a timely interval.
- Repeated sharp turns in cornering and frequent, rapid changing of lanes at a high speed. River wear tends to be created in steering or trailer axles.

- Do not overload tyres. Maintain recommended inflation pressure for the axle loads imposed.
- Rotate tyres timely in accordance with recommended rotations to avoid river wear.
- Avoid rough driving.

Inspect the main grooves visually.
