TREAD

One side of the blocks and/or lugs on the tread wearing faster than other side circumferentially like saw teeth.

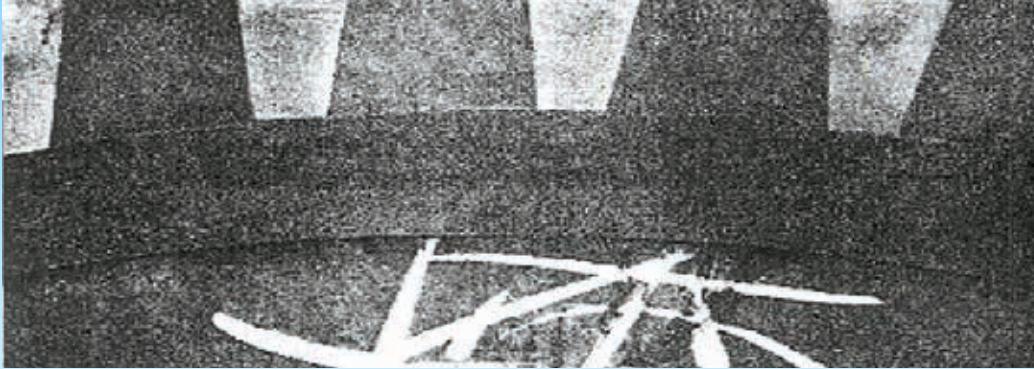
- Under inflation and/or overload.
- Tyres have not been rotated at a timely interval.
- Sudden braking and rapid acceleration.

- To use and maintain tyres at the correct air pressure for the axle loads imposed.
- Rotate tyres timely in accordance with recommended rotations to avoid heel & toe wear, taking into account change of rotational directions.
- Avoid rough driving.

Inspect the tread visually.
