TREAD

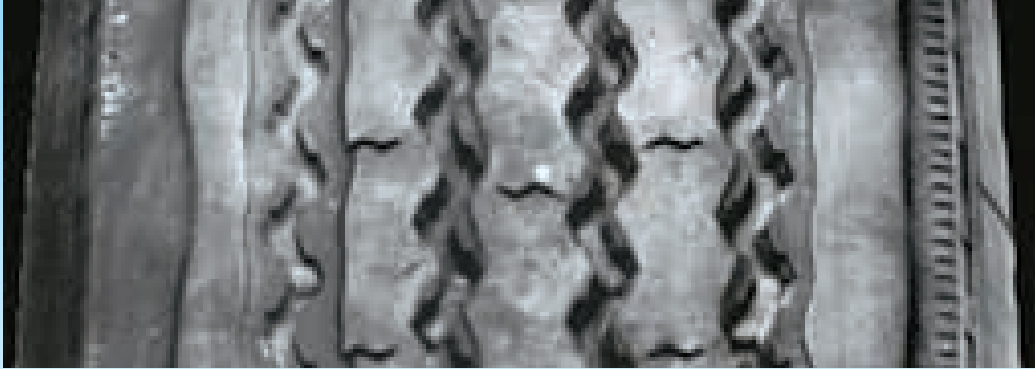
Edges of the ribs except the outer edge of the shoulder ribs wearing faster than the tread surface like a riverbed.

- Under inflation and/or overload.
- Tyres have not been rotated at a timely interval.
- Repeated sharp turns in cornering and frequent, rapid changing of lanes at a high speed. River wear tends to be created in steering or trailer axles.

- Use tyres under the recommended air pressure and load.
- Rotate tyres timely in accordance with recommended rotations to avoid river wear.
- Avoid rough driving.

Inspect the main grooves visually.
