TREAD & CARCASS

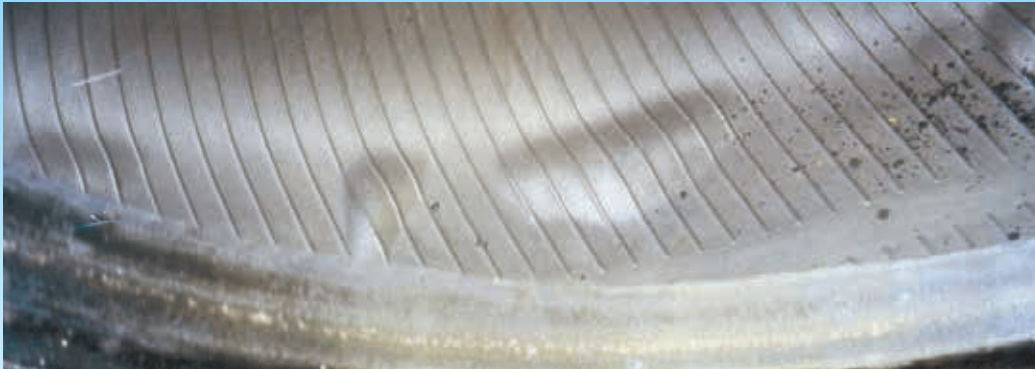
Separation between inner liner rubbers, inner liner rubber and carcass in tubeless tyres.

Deteriorated adhesion by excessive stress and/or heat due to:

- Under inflation and/or overload.
- Excessive speeding.
- External impact in the shoulder area.
- Riding up and down curbs etc.

Liner separation is distinguished from Tread Separation by bulging inside the tyre.

- Use tyres at recommended pressure and do not exceed maximum load (Load Index).
- Drive at an appropriate speed.
