AREA:

BEAD

CONDITION:

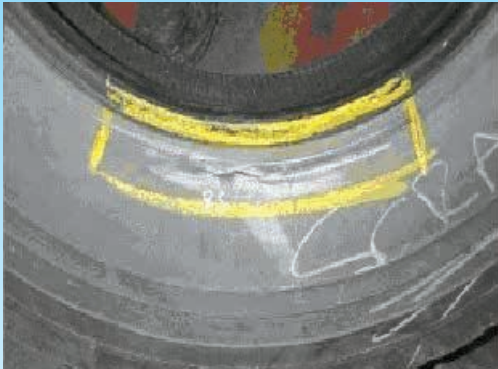
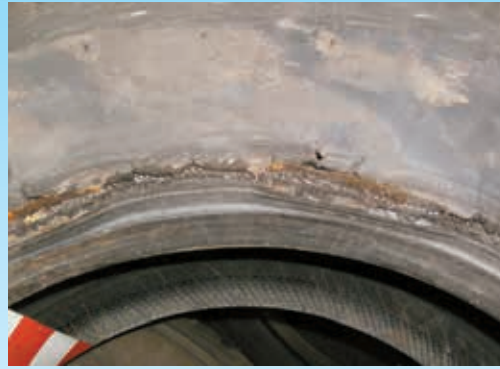
Chafer Separation: Separation in chafer (steel, textile) and rubber, chafer and chafer, or chafer and carcass.

Turn Up Edge Separation: Edge of carcass layer separating.

This damage appears as cracks or swell on outside bead, or separations on inside bead.

Fatigue of adhesion between rubber and cord by excessive stress and heat due to:

- Under inflation and/or overload.
- Excessive speed and/or braking.
- Fast cornering.
- Improper rims (improper size, flange, etc.).
- Faulty (deformed, rusted) rims.

Inspect outside-bead for cracks or swells and inside-bead for separations. At the same time, check for tyre overloading in the bead (deformation, abrasion) and tread areas (shoulder wear, heel & toe wear).

Inspect cracks along the whole bead, and at the same time, check the used rim (size, flange, contour etc). Finally, check condition of use (air pressure, speed etc).

- Use tyres under the recommended air pressure and load.
- Avoid excessive speeding, sudden braking, and fast cornering.
- Use correct rims (size, flange contour) without deformation and rust.
