Truck Tyre Injury Guidance

Side Cut (through)

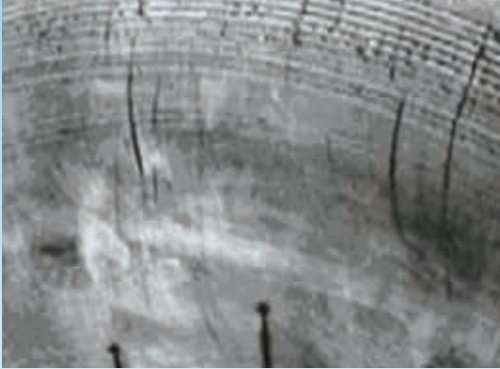
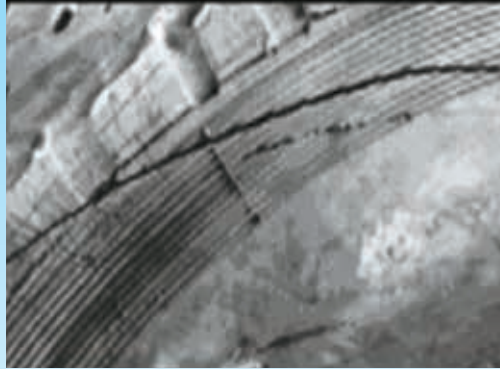
AREA: SHOULDER & SIDEWALL
CONDITION: Cuts in shoulder or sidewall.

CAUSES:

- Contact with curbing, pit rails & general road hazards.

RECOMMENDATIONS:

- Avoid obstacles where ever possible; if the obstacles cannot be avoided reduce the speed.
- Check dual tyres frequently, remove stones caught between the duals immediately, and repair damage immediately.
- If the damage is superficial and has not reached the ply cords the tyre can be turned on the rim and continued in service. If the tyre has body ply exposure remove immediately from service and repair within the recommended limits.

Check if the cuts are occurring at similar positions on the sidewall/shoulder and are visibly comparable to each other and if so investigate vehicle operations to determine the cause of the damage.
