**AREA:** TREAD & CARCASS

**CONDITION:** Separation between tread rubber and belt (breaker), between belt (breaker) layers, or between belt (breaker) and carcass.

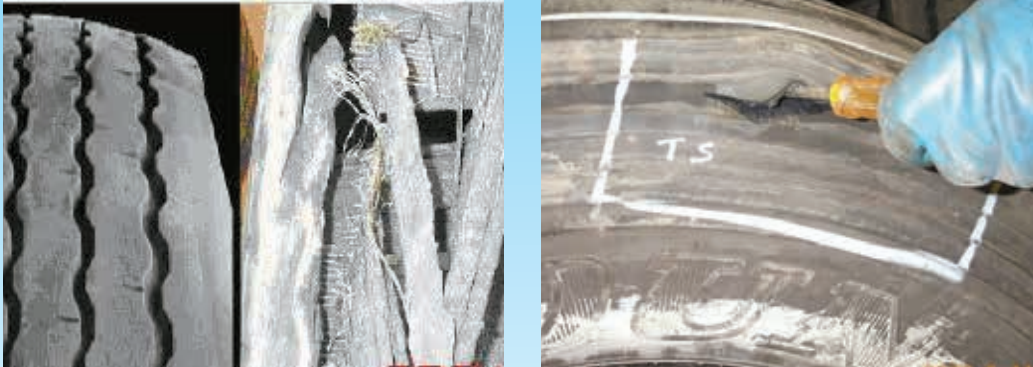
Breakdown of adhesion between components in the tread areas due to:

- Under inflation and/or overload.
- Excessive speed.
- Fast cornering.

- Use tyres at recommended pressure and do not exceed maximum load (Load Index).
- Drive at an appropriate speed.
- Avoid fast cornering.

To check if tyre has been over deflected inspect the inner liner looking for signs of creases (circumferential dark lines, rubber crumb) and inspect the bead area for discolouration (Blue colour) and abrasion.

Make distinction among tread separation, cut separation and heat separation.
