AREA: SHOULDER & SIDEWALL

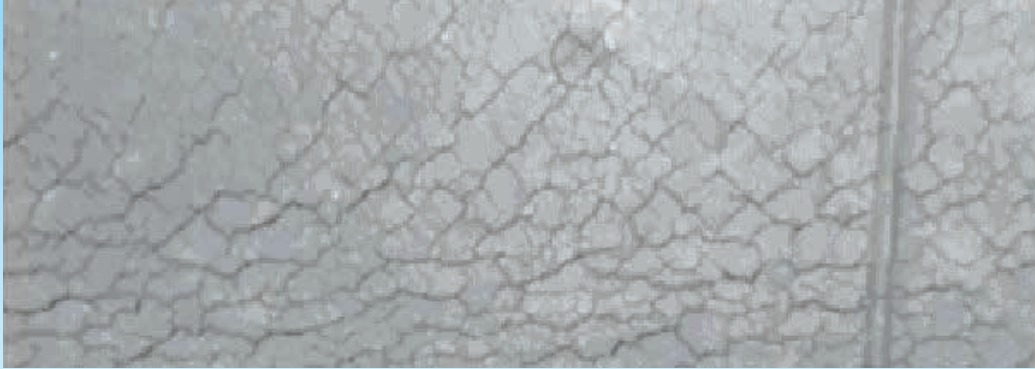
CONDITION: Mosaic like cracks in the sidewall rubber due to oxidation and exposure.

- Normal aging condition but can be accelerated by extended periods where vehicles are stationary and the sidewalls are not flexing sufficiently to allow the mechanism of the anti ozonic chemicals being worked to the surface.
- High exposure of certain detergents during the vehicle washing procedure.

- Keep stored tyres away from direct sunshine, ozone, heat and equipment (such as generators, mercury vapour lamps and electric welding equipment).

Check the stored conditions and find whether chemicals such as wax are used to polish the sidewalls.
