TREAD

One or two ribs in the centre of tread wearing faster than the other ribs.

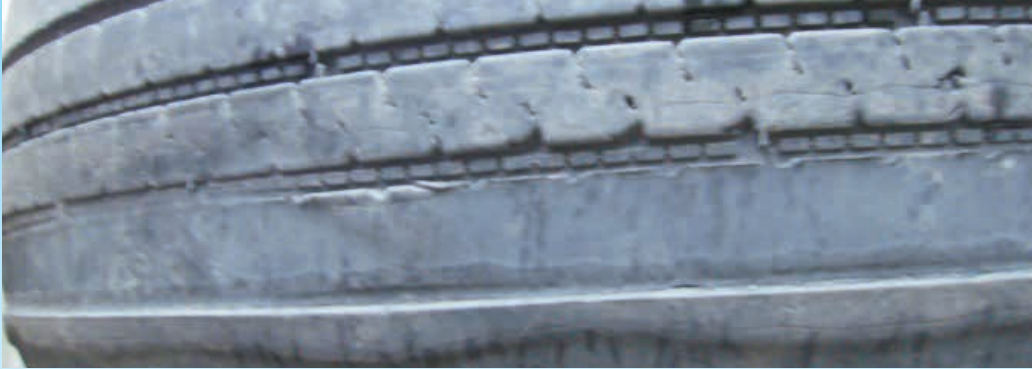
- Faulty suspension or faulty rotating parts such as bearing and axle beams.
- Under inflation.
- Incorrect wheel alignment.
- Mismatched tyres and rims.

This type of tread wear is commonly found on free rolling axles of long distance operations.

- Adjust mechanical fault correctly.
- Do not overload tyres. Maintain recommended inflation pressure for the axle loads imposed.
- Adjust wheel alignment correctly.
- Correct matching of tyres and rims with proper mounting of the tyres.

Visually identify the difference between the normal rib and the depressed rib and measure grooves with a depth gauge.
