# Truck Tyre Injury Guidance

## Step Wear

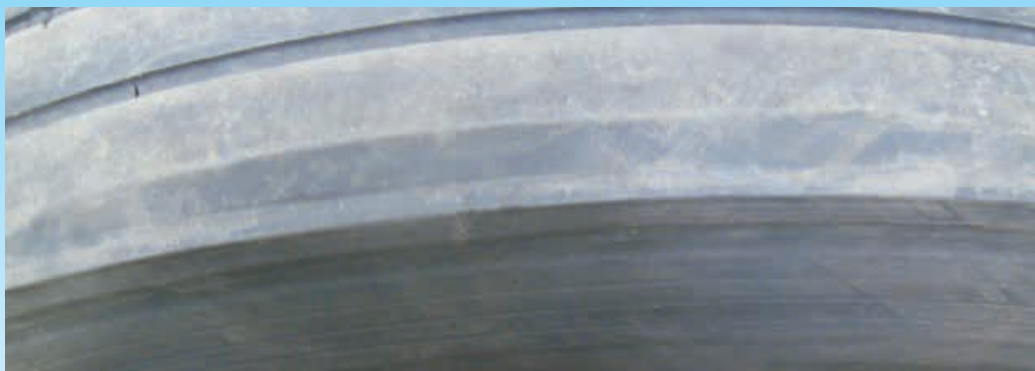
The outer portion of the shoulder rib wearing faster than the inner portion.

- Incorrect air pressure.
- Incorrect wheel alignment.
- Mismatched tyres and rims.
- Repeated sharp turns in cornering and frequent, rapid changing of lanes at a high speed.

- Do not overload tyres. Maintain recommended inflation pressure for the axle loads imposed.
- Adjust wheel alignment correctly.
- Use correct rims and the proper procedures for mounting of tyres.
- Avoid rough driving.

Inspect the shoulder ribs visually.
